A Behavior of Unsteady Cavity on a Wing Section

Noritane Chiba
Miyakonojo National College of Technology
Miyakonojo, Miyazaki, Japan

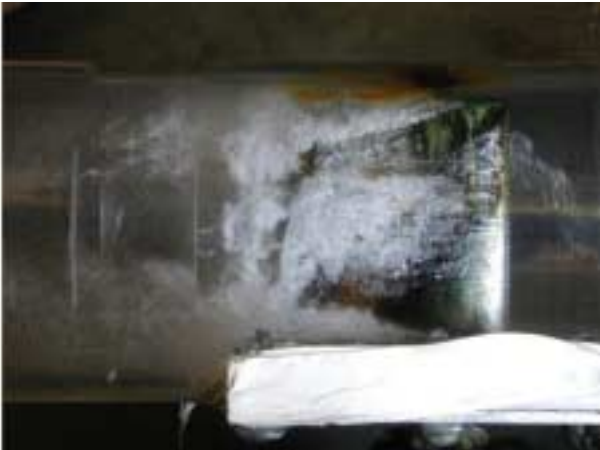
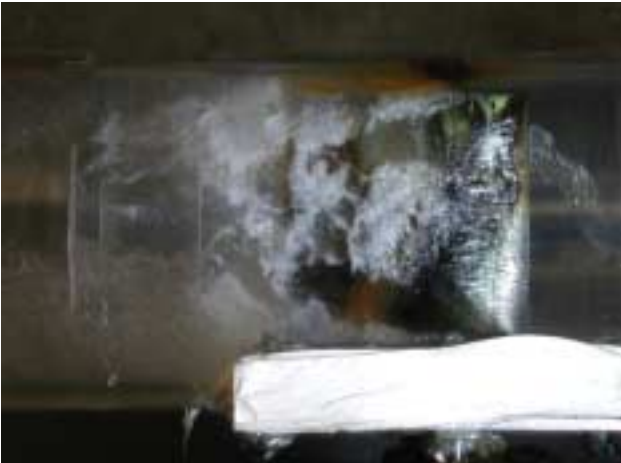
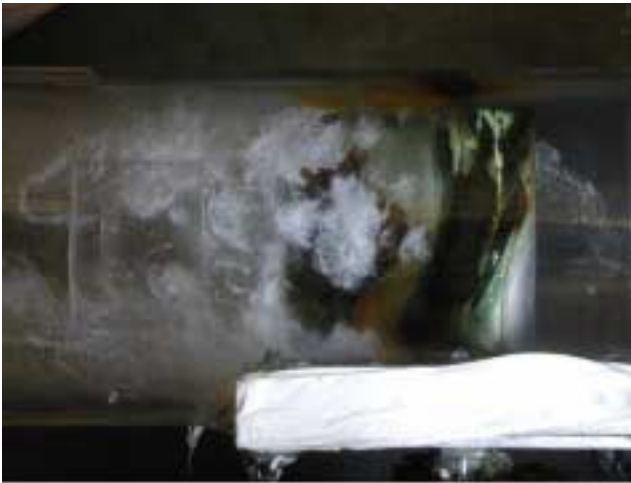
Figure 3 Cavities at Hammer Height =73.2 mm

(1) hammer height=73.2mm are shown in Figure 3.

The cavity at 10 degree was fully developed. As the attack angle decreased the cavity began to shrink. At 0 degree, the rear part of cavity was going to collapse, while the fore part looked like a shrinking sheet cavity. At -6degree, the rear part collapsed as a whole and became cloud cavity. This cloud cavity resembled that on the blade of pumps. In this case a half volume of the initial sheet cavity were concerned with the energy of cavity collapse. The fore part disappeared toward the leading edge of the wing.

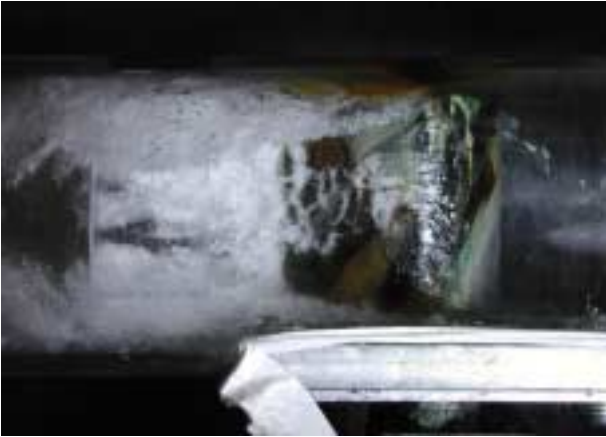
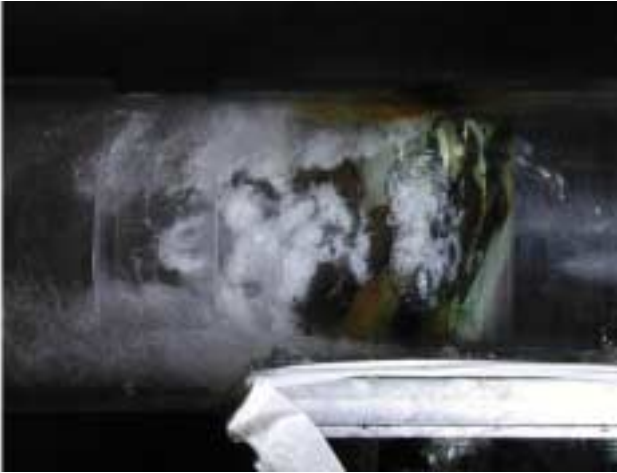
Figure 4 Cavities at Hammer Height =250 mm

(2) hammer height =250 mm is shown in Figure 4

The cavity at 8 degree splitted into the rear part and fore part. At 4 degree, the rear part collapsed. The fore part became the narrow sheet cavity parallel to the leading edge of the wing. This sheet cavity situated at some distance from the leading edge of the wing. The unsteady cavity left the leading edge of the wing, as is often the

case on the blade of hydraulic machinery. At 0 degree, the rear part rebounded and became cloud cavity. The fore part collapsed near the same position on the wing at 4 degree. The whole potential of the initial sheet cavity was converted into the two collapses of cavities.

The initial sheet cavity left the leading edge of the wing in the two cases, hammer heights= 250 and 426.8 mm. The narrow sheet cavity, which was the fore part of the split initial sheet cavity, shrunk as follows. The downstream edge of narrow sheet cavity moved towards upstream with a certain speed .

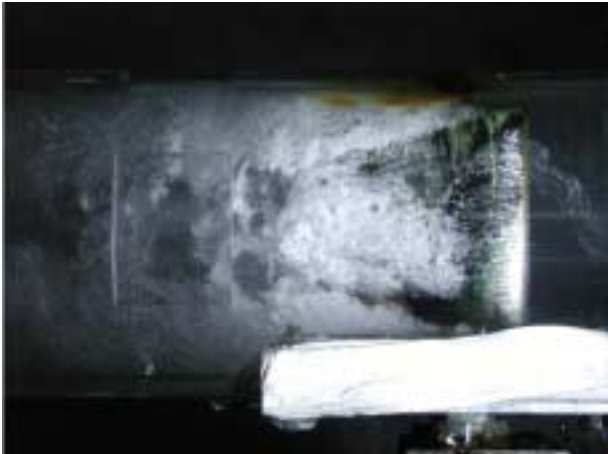
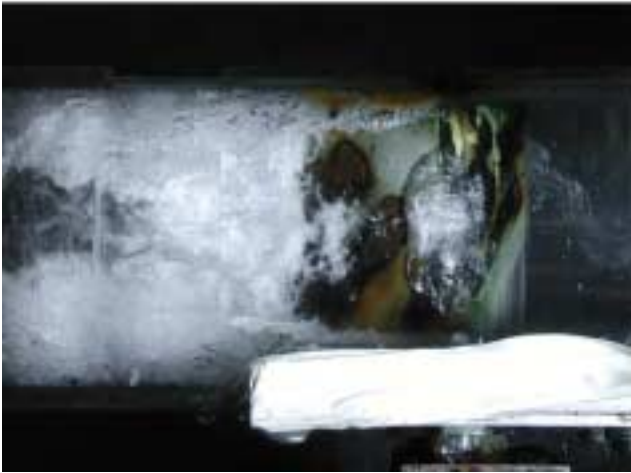
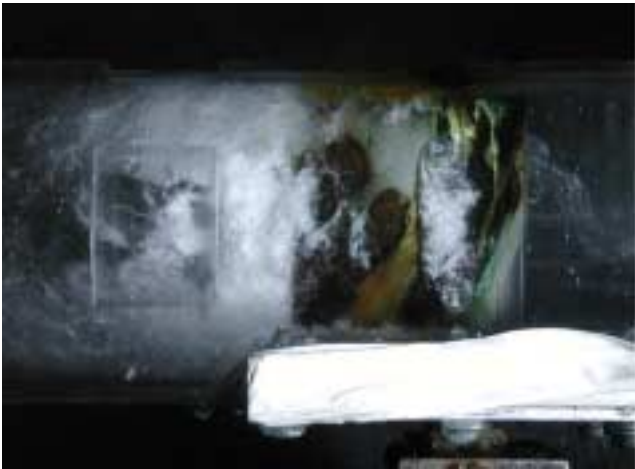
Figure 5 Cavities at Hammer Height =426.8 mm

(3) hammer height =426.8 mm

The behavior of the unsteady cavity relatively similar to that at hammer height = 250 mm.

But the fore part carried the larger part of the initial cavity. Therefore the collapse of the fore part seemed to be dominant.
